Federal Aviation Administration-Great Lakes Region Condensed Environmental Assessment (CEA)

Airport Name:	Indy South Greenwood Airport			Airport Identifier:	HFY	
Address:	897 Airport Parkway					
City:	Greenwood	County:	Johnson	State:	IN

Appendix A - Exhibits

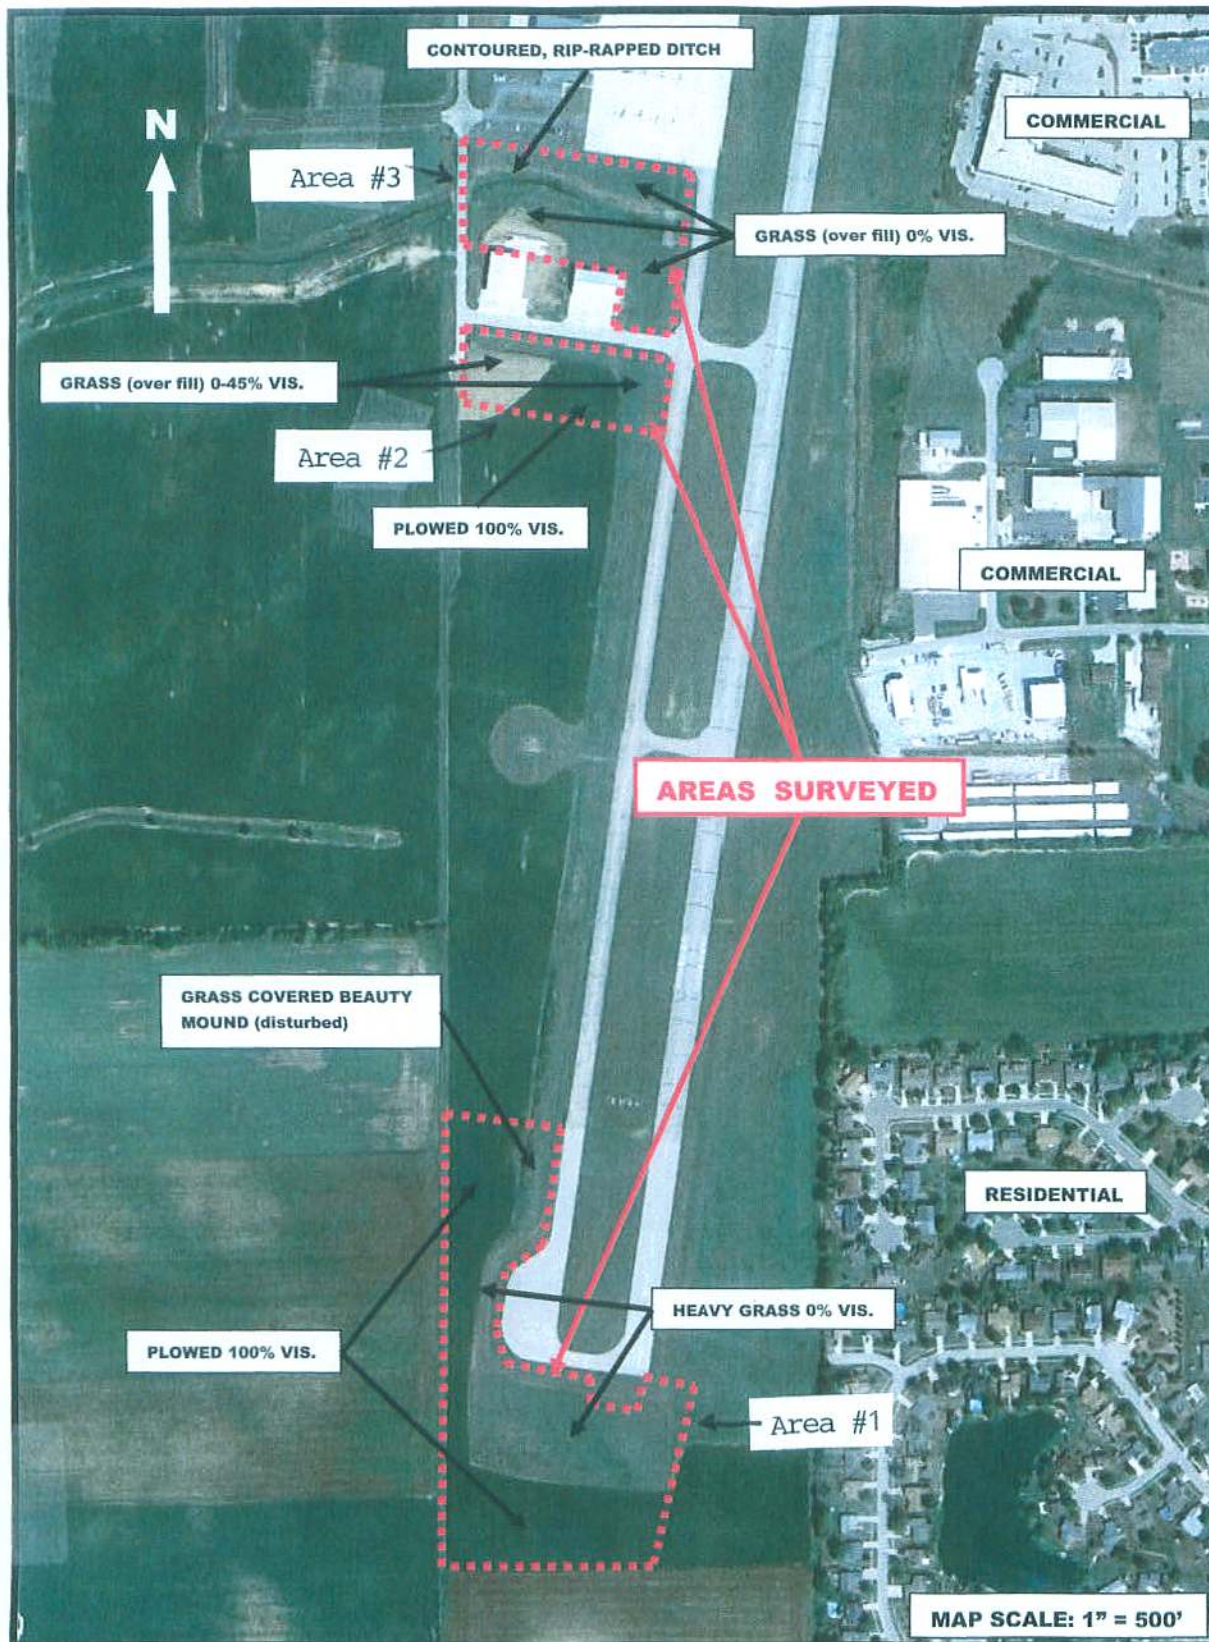
Figure 3. Aerial Map of the Survey Areas.

Area #1 contained a mix of tilled agricultural field and grass covered ground (Figure 3). All of the tilled farm field within the survey limits was examined through pedestrian means. The grass covered areas were shovel tested. Shovel tested areas identified both agricultural and non-agricultural disturbance. Non-agricultural disturbance was noted on shovel probes excavated on a beauty mound west of the airport taxiway/runway (Figure 3). Shovel probes easily determined that the beauty mound had been constructed from fill deposits. Shovel probes dug at the southern end of the airport taxiway/runway identified the existence of an agricultural plowzone within the wall profiles of the test pits. The plowzone extended up to 8.5 inches below the ground surface. No archaeological resources were found in Area #1.

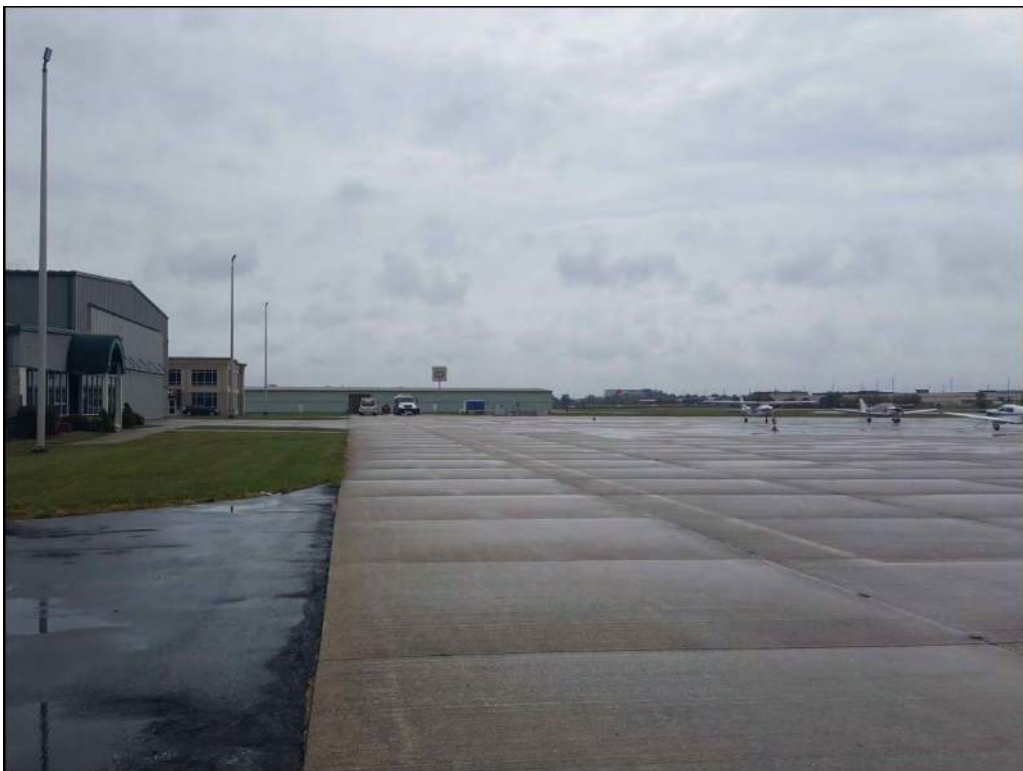
Photograph A6. Looking north across the existing apron and apron lighting within the airport.

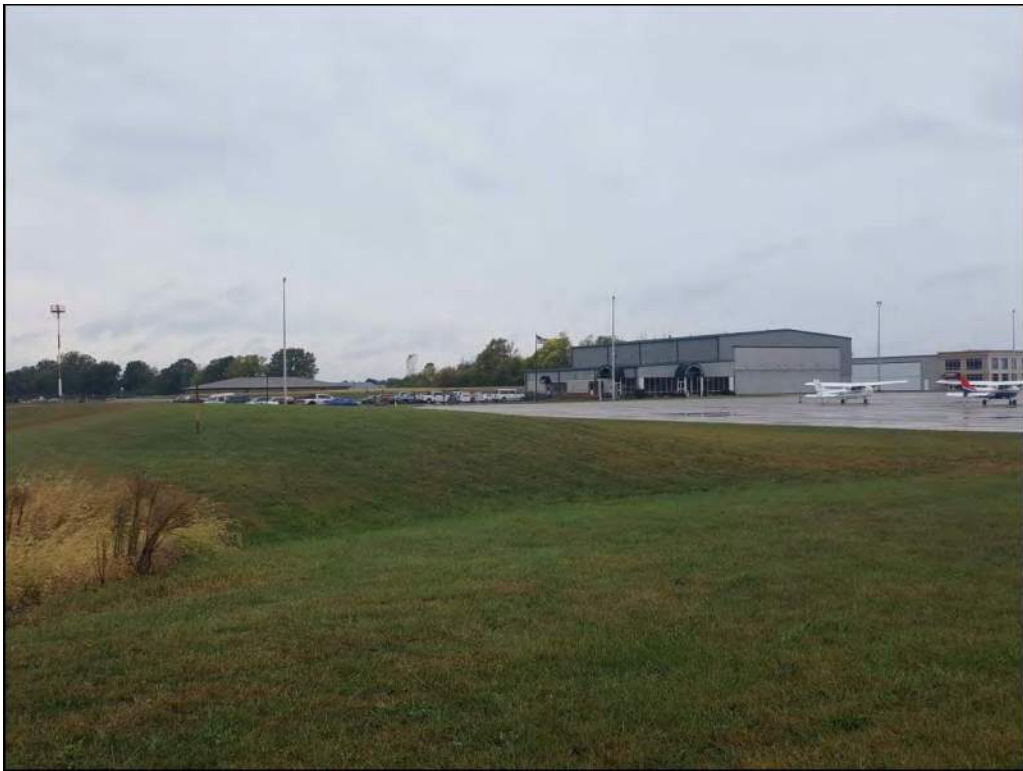
Photograph A12. Looking northwest from the runway at the project area and existing apron lighting.

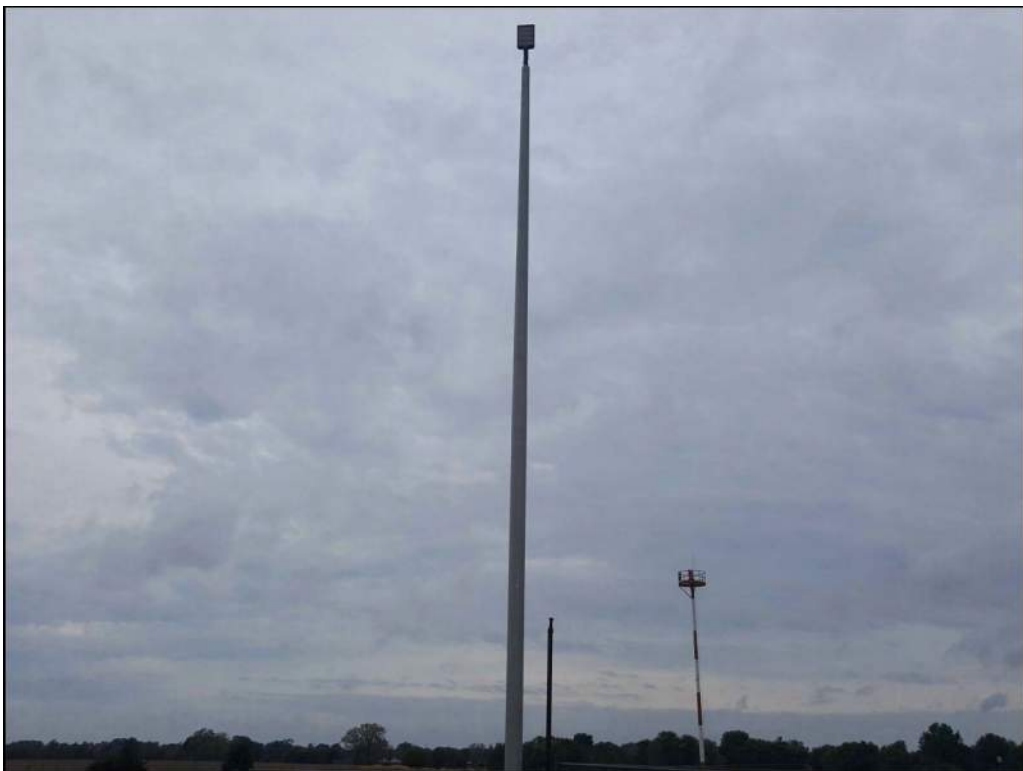
Photograph A36. Looking west at the existing apron lighting. Note the red and white tower referenced during the resident interviews.
